Manhole Inspection Summary

Manhole # S41U1_005MH

Insp Date: **12/4/07 7:55 AM**

Location Address: **3426 6th St**

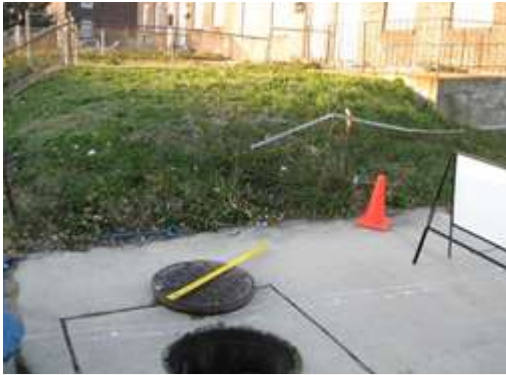
Location View

3426 6th St

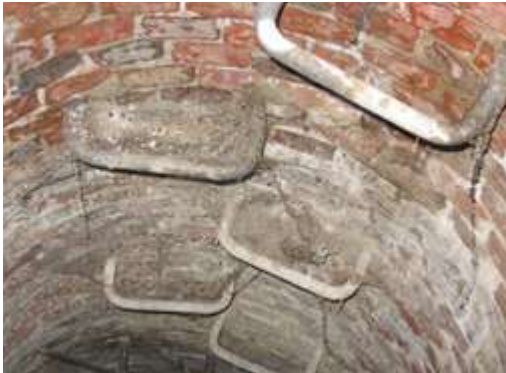
steps

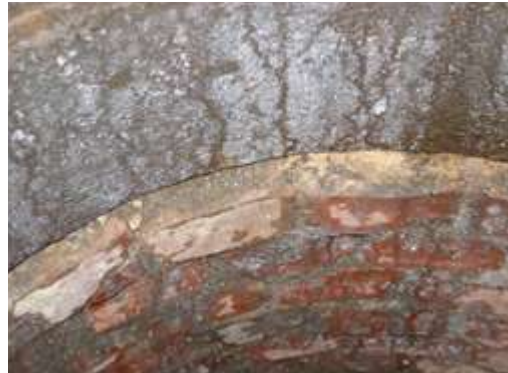
Defect 1

Frame Offset: **4** (in.) Condition: ☒ Sound ☐ Cracked ☐ Leaks

offset frame

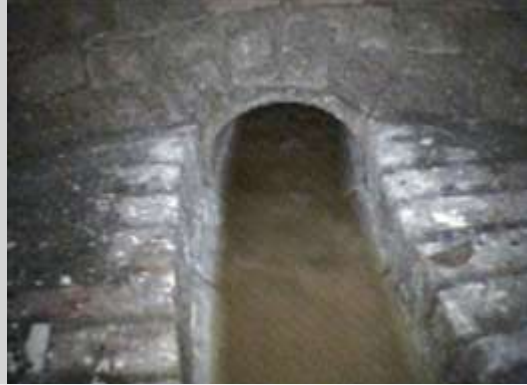
12 O'Clock Outflow

8 in. Circular Gravity Sewer
Pipe Out @ 12 O'Clock

Pipe Material: **Clay** ☐ Pipe Lined

Deposits: ☒ None ☐ Mud ☐ Sludge ☐ Debris ☐ Grease

Infiltration: **None** Pipe Seal Cond: **Sound**

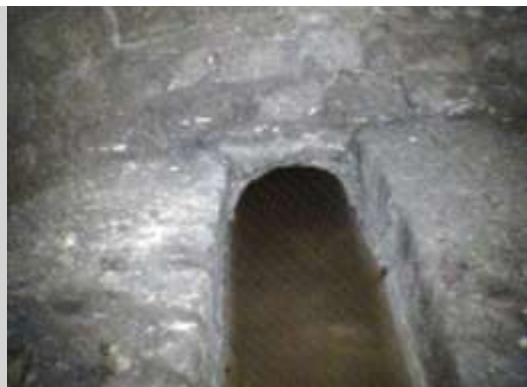
6 O'Clock Inflow

6 in. Circular Service Sewer
Pipe In @ 6 O'Clock

Pipe Material: **Clay** ☐ Pipe Lined

Deposits: ☒ None ☐ Mud ☐ Sludge ☐ Debris ☐ Grease

Infiltration: **None** Pipe Seal Cond: **Sound**
